Saddle Fit Thermal Imaging Report

Mikado

PATIENT: Mikado **THERMOGRAPHY DATE:** June 10, 2014 **TIME:** 4:00 pm

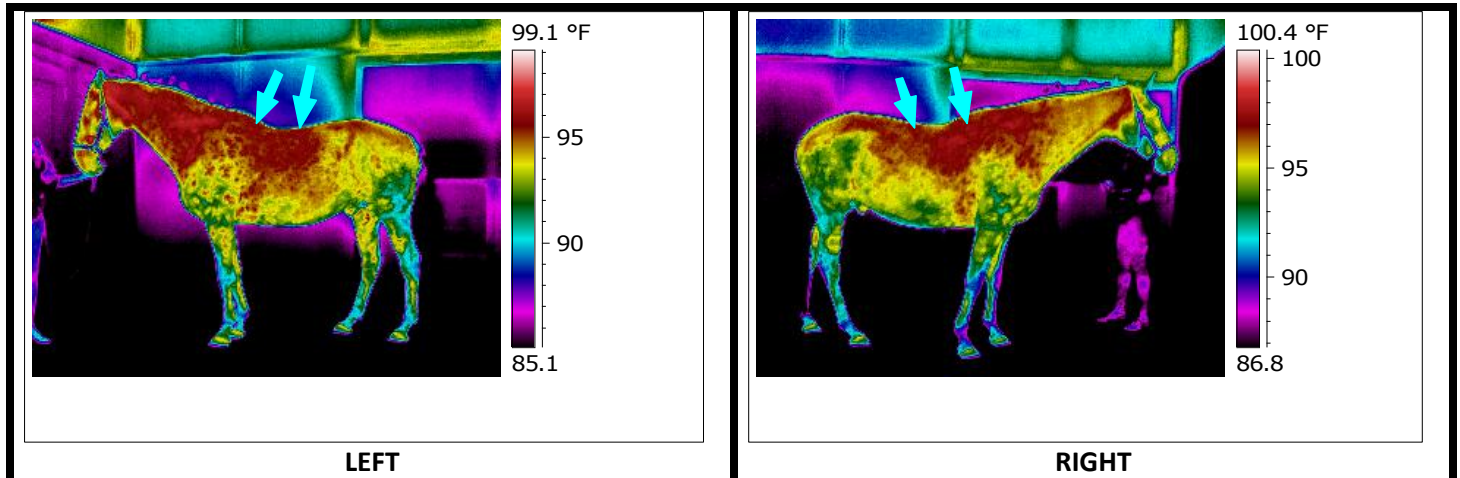
Whole horse views as seen in full scan – some changes are noted at the proximal left neck, the gluteals/hip region, and at the trapezius muscles and paraspinals bilaterally.

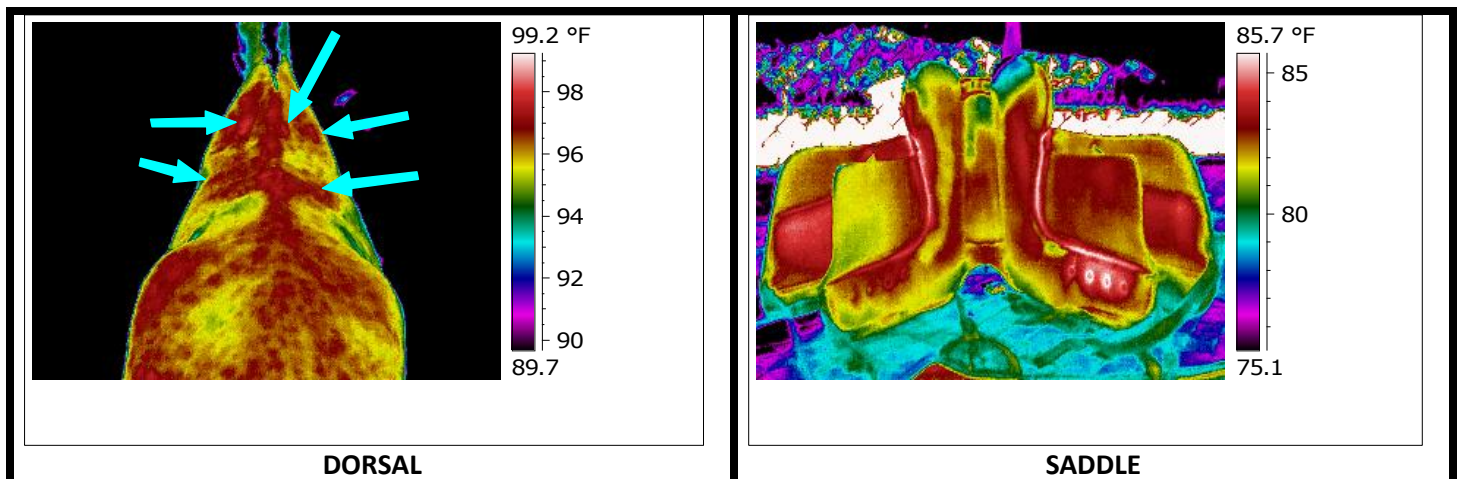
Pre dorsal view again highlights focal trauma at the shoulder holes bilaterally, and into the lower thoracic spine and paraspinal muscles bilaterally. There is asymmetry in patterning along both sides.

NOTE: Saddle was in clients vehicle during full scan and appears sun may have been hitting side panel. A 8-10 minute acclimation period in the shade was done prior to imaging baseline.

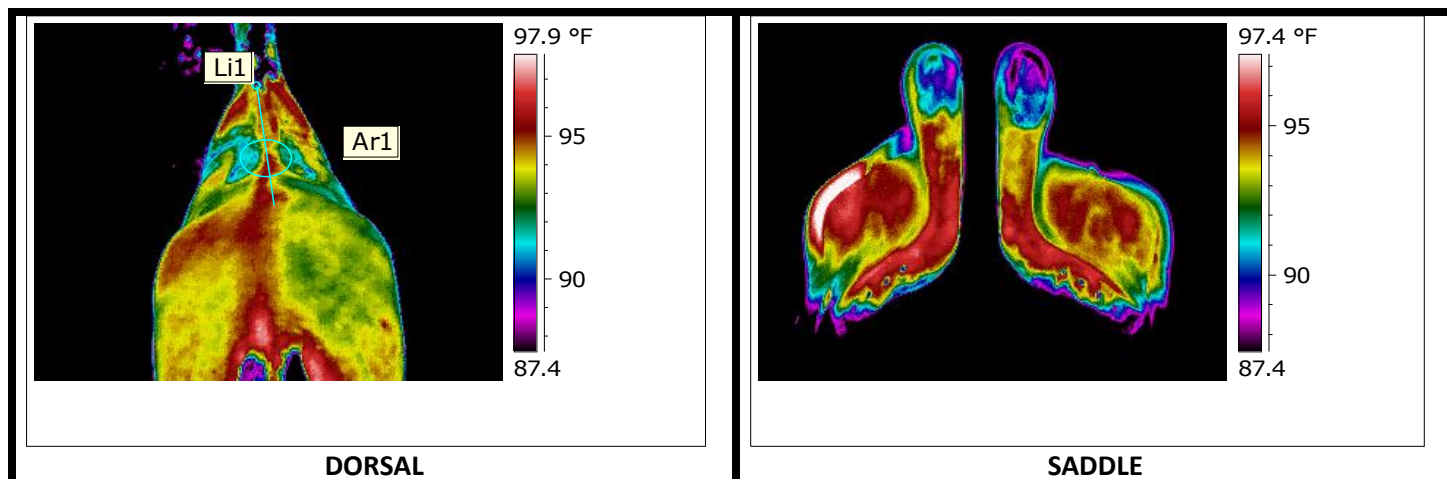
Dorsal patterning is abnormal and suggests issues with uneven contact. There appears to be too much pressure at the front of the saddle, likely dropping into the shoulder holes; the panels have uneven contact – more on the left than on the right, and the left sweat flap shows more heat, consistent with the rider’s leg having more contact and the saddle likely twisting or falling from left to right. Parallel lines in the horizontal panels also suggest there may be saddle-rack damage in this saddle? Evaporation at the rear panels suggests friction/pressure consistent with large potentially over-stuffed gussets or the saddle slightly popping up behind – see summary. Channel appears to be slightly narrow over the TL junction and could be wider for this patient; local irritation is noted.

Patterning in the patient’s topline suggests saddle fit issues, and the thermal scan confirms some fitting problems.

There is uneven contact from left to right, and there appears to be focal pressure over the trapezius muscles bilaterally which is undesirable. There should be space at the top of the panel to allow for the patient’s shoulder blade to move evenly beneath the tree. Flocking to fill the shoulder holes can create performance problems by impinging on nerves and blocking a full range of motion. The left horizontal panel has more contact than the right side, and there appears to be a slight left to right shift or twist, though the patient appears to be generally symmetrical in the shoulders (not grossly bigger on one side).

Patterning at the rear of the panels is harder to interpret because of the evaporation, but it can be seen with two things – one (and more likely) too much pressure from firm or overstuffed large gusseted panels (often designed with the idea of pressure distribution, but sometimes having the opposite effect), or two – friction created by lack of contact, which isn’t a bad thing in the overall context IF the tree is a correct fit because the rear of the saddle should allow the horse’s back to lift into contact. One would have to assess these factors in person to determine if the panels under the cantle are overstuffed putting too much pressure in the back (likely, given the patterning in the patient’s back), or if the saddle is dropping down and lifting at the back (place the saddle, and put pressure over the pommel –watch and feel to see if the saddle drops into the shoulders and raises in the back). If the saddle drops into the

Lines in the panels suggest there may be saddle-rack damage? The saddle should be stored on a single beam down the center of the channel – many racks are designed for Western saddles and damage panels on English saddles, creating wrinkles in the leather and flocking. Flocking will also settle after being redone and should typically be rechecked periodically to correct settling and shifting.

The channel appears even and without heat, though could be wider for this horse given the focal T18-L1 irritation seen in the dorsal images, and the length appears appropriate on this horse in these images, but the tree angle needs to be assessed, and current fit is not balanced or symmetrical for this patient; primary concern being the pressure over the trapezius muscles and blocking the shoulders. Patterning is consistent with ongoing pressure points as well as back pain and inflammation in the shoulders, muscles, and spine which will affect performance and create an unhappy horse.

shoulder holes and creates pressure where you cannot place your hand between the upper panel and the shoulder – it is too tight and does not fit.
