Thermal Imaging Report

Zippo My Lady

PATIENT: Zippo My Lady

THERMOGRAPHY DATE: September 5, 2013

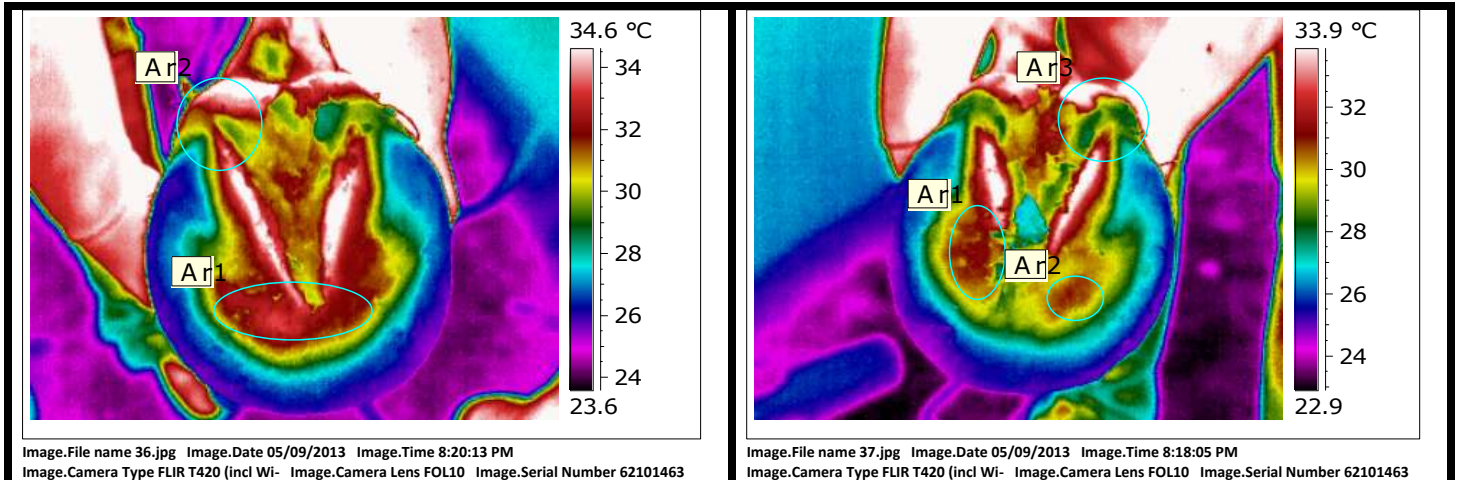
There is a bit of wall and bar flare and uneven heel pressure. Increased heat/pressure seen in LF at the toe, greatest at the lateral toe quarter and in the RF at the lateral quarter. Increased heat in the frog sulci may represent infection. There may be uneven loading of the limb causing the focal pressure or hoof imbalances. The digital images were difficult to evaluate. Thorough visual exam recommended.

Mild flare and hoof imbalances are seen in the thermal images of the feet. All frog sulci have increased heat which may represent infection – probing of the area recommended. This extends into the heel area in some views. The increased heat in the lateral toe quarters of the left front and left hind feet may be due to inflammation/infection or uneven loading of the foot either from imbalances of the foot and/or

uneven loading of the limb due to injury or pain. Thorough visual examination of the feet, hoof tester evaluation and postural analysis recommended for further work-up.
