# Thermal Imaging Report

## Risky Business

EquineIR was recently requested to perform a full body thermal imaging scan of: **Risky Business**

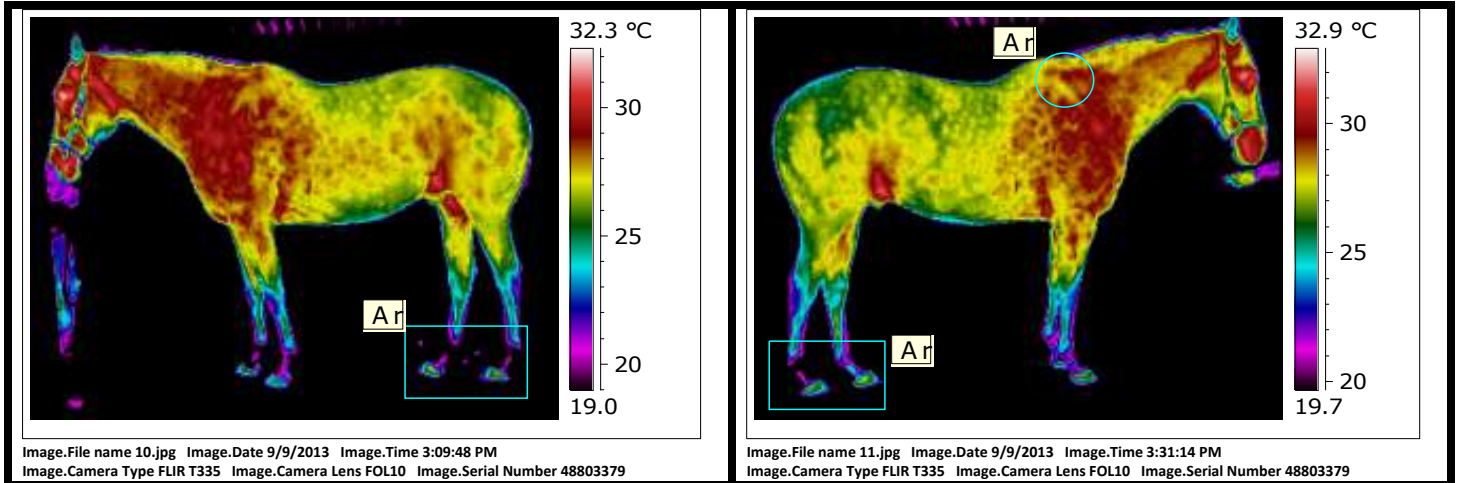
Lateral views have good symmetry – there is artifact present. Comments are based on images submitted. Horse appears down in the fetlocks of both hind limbs and has increased heat in the hind feet, greatest at the heels. This would be consistent with suspensory laxity. The right hindquarter is slightly cooler than the left suggesting uneven limb loading. The right front shoulder/wither area has slightly greater heat than the left which may indicate saddle fit issues, chiropractic issues and/or uneven limb loading.

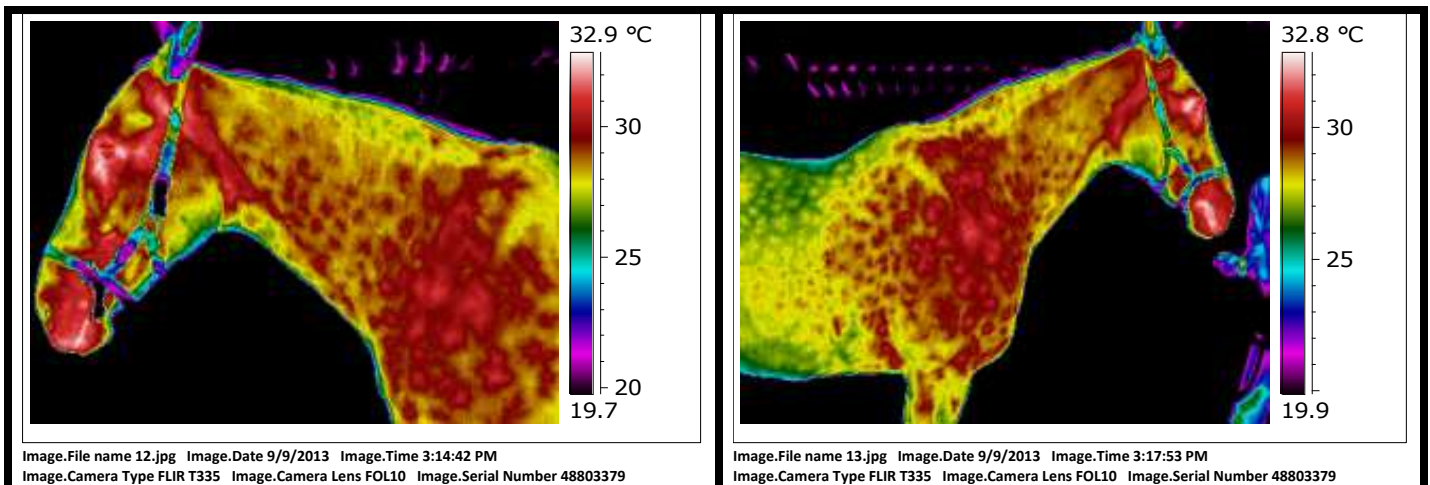
**NSF: No Significant Findings**

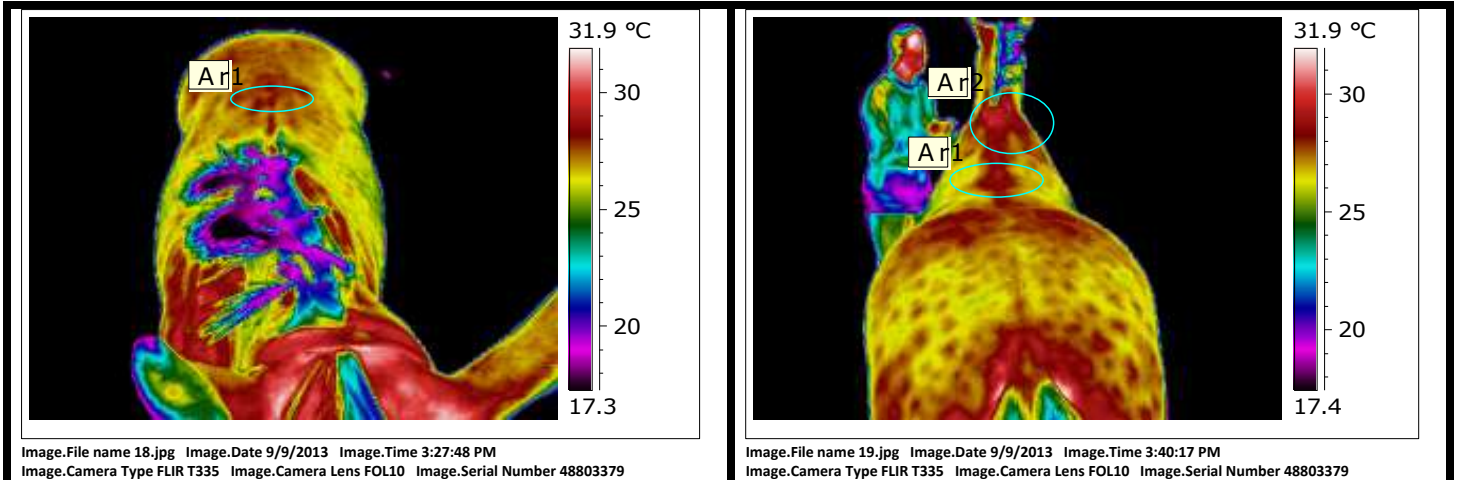
**Increased heat withers and thoracolumbar spine. Some of the increased heat in the spine may be due to conformation, but the area of extension into the paraspinal muscles suggests inflammation from chiropractic lesions, saddle fit issues or kissing spines. Chiropractic evaluation, saddle fit analysis and ultrasound would be valuable for further evaluation.**

There is increased heat in the withers and spine indicating that there are possibly still saddle fit issues and/or chiropractic issues present. A saddle fit scan/analysis is highly recommended based on the history of repeated saddle adjustments. The history of stiffness and reluctance to be saddled could correlate with saddle fit issues and/or gastric/colonic ulcers. History also shows horse on medication but certain types of ulcers can be very resistant and require a combination of medications to resolve. Endoscopy recommended for further evaluation of the stomach. The increased focal heat in the thoracolumbar spine may also be due to chiropractic lesions or kissing spines. Veterinary chiropractic evaluation and possible ultrasonic imaging of the area recommended.

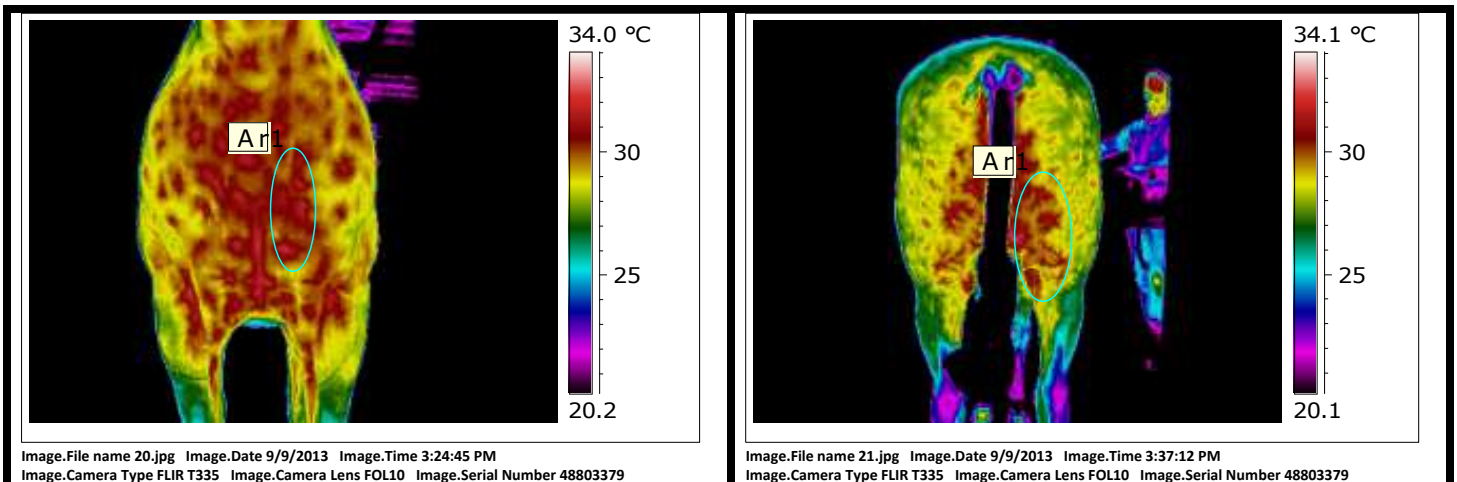
**Slight asymmetry in the chest with heat greater on the right side which may be due to primary muscular inflammation/strain or off-loading of other limb. Palpation recommended.**

There is slight asymmetry in the chest and semitendinosus which may be due to uneven limb loading or mild local inflammation or environmental artifact. Palpation recommended. It does appear to be consistent with the history of diagonal tension.

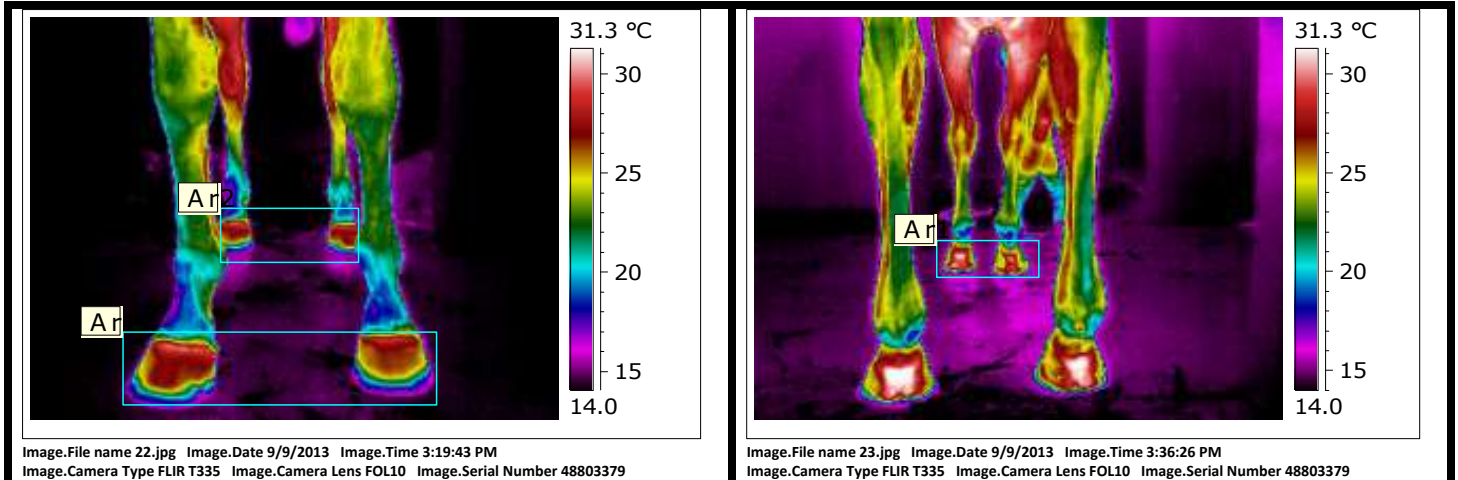
**Heat pattern in the feet suggests stress in the feet. Artifact appears to be present in lower limbs. Heels have increased heat indicating stress and front feet have uneven pressure, with the left front appearing to have greater heat/pressure than the right. This may be due to uneven limb loading or inflammation.**

There is heat patterning in the feet and tendons that suggest strain and the digital images show lack of support under the fetlocks and suspensory apparatus. This maybe e partially due to conformation/inherent tendon/ligament laxity and extra support via trimming and shoeing may be required. The feet have increased heat at the heels, uneven pressure medial to lateral across the heels, uneven sole pressure and shoe placement. A farrier consultation may be helpful with our farrier consultant, Mike DeLeonardo of DeLeonardo Farrier Service. This may be set up by phoning 831-442-9154.

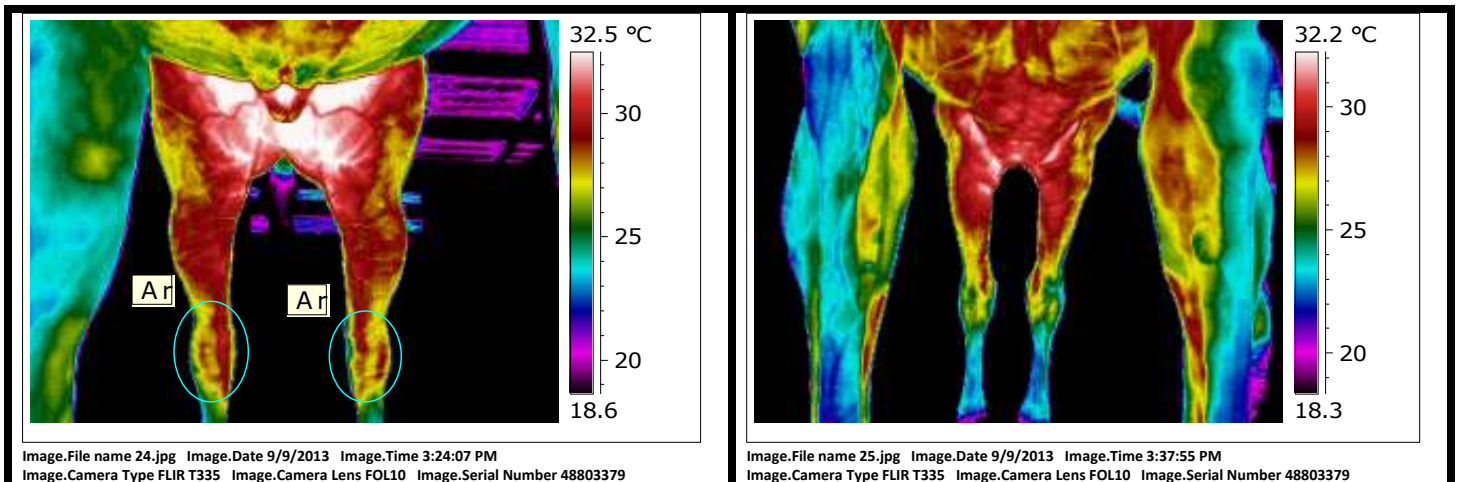
**Increased heat in both hocks. Gait analysis and flexion testing recommended checking for tarsitis. Front limbs appear fairly symmetrical and though there is slightly greater heat on the right there is also light artifact seen on the right front limb.**

There is heat seen in both hocks, slightly greater on the left which may indicate tarsitis. Gait analysis and flexion testing recommended for further evaluation. Radiographs may also be warranted at that time.

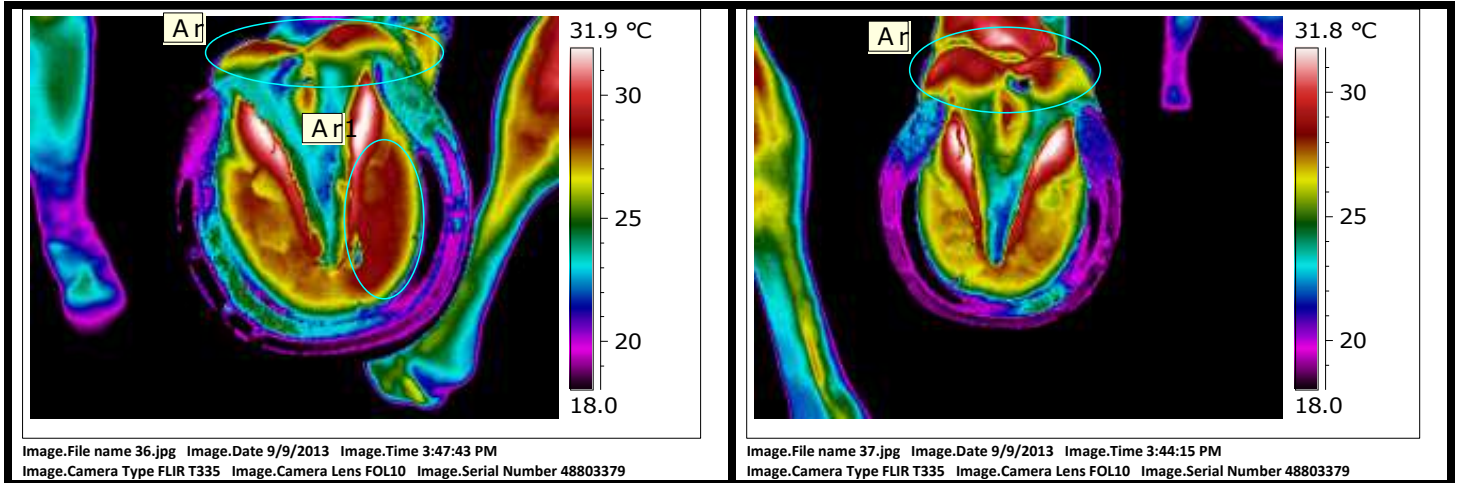
There is uneven pressure at the heels on both front feet with pressure greater on the left front medial heel and right front medial heel. Left front shoe appears to be set crooked. There is increased heat/pressure medial quarter left front foot and slightly greater at the later toe quarter right front foot. This may be due to uneven limb loading or imbalances in the foot.

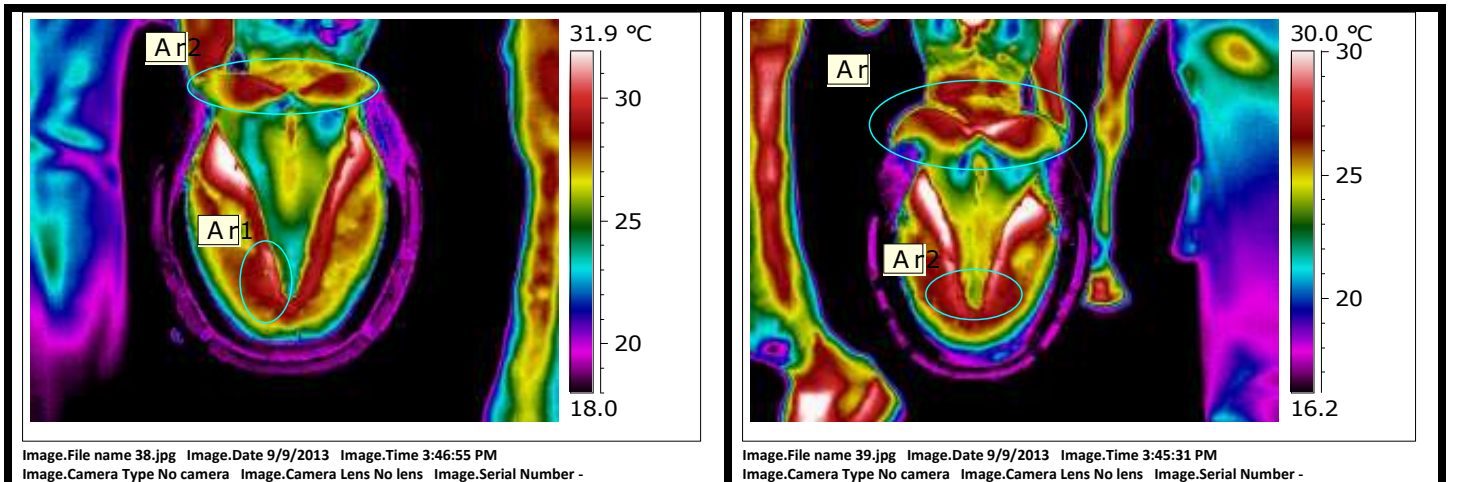
Uneven heel pressure both hind feet and left hind shoe appears to be set crooked. Slight increase heat at toe of both hind feet.
